Manhole Inspection Summary

Manhole # S43A__016MH

Insp Date: **7/18/08 11:20 AM**

Location Address: **1501 jefferson st**

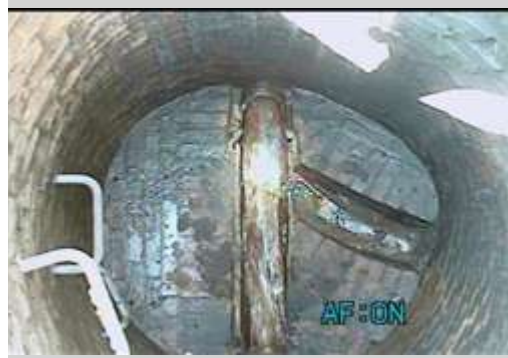
Top View

& steps

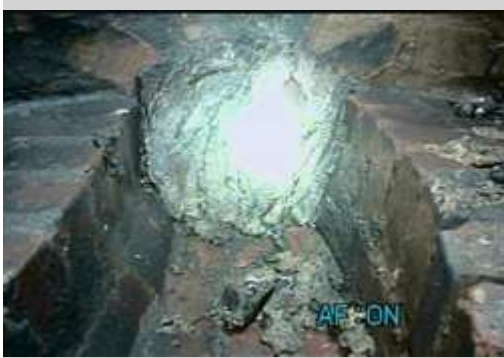
Misc

Comments **3 sealed off**

sealed pipe

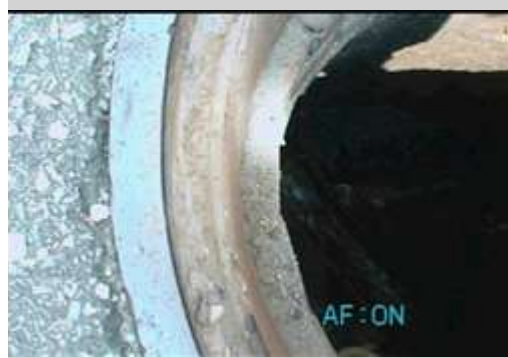
Defect 1

Frame Offset: **1** (in.) Condition: ☒ Sound ☐ Cracked ☐ Leaks

offset

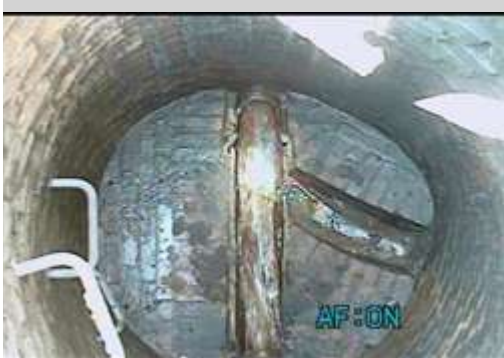
Defect

Steps Count: **3** Missing: **0** ☒ **Corroded**

Corroded steps

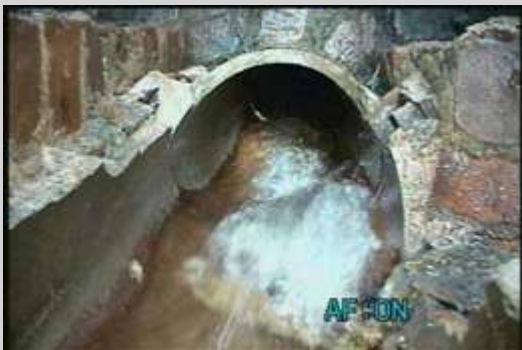
12 O'Clock Outflow

8 in. Circular Gravity Sewer
Pipe Out @ 12 O'Clock

Pipe Material: **Clay** ☐ Pipe Lined

Invert Depth: **8.15** (ft.) Flow Characteristics: **Fast**

Infiltration: **None** Pipe Seal Cond: **Unknown**

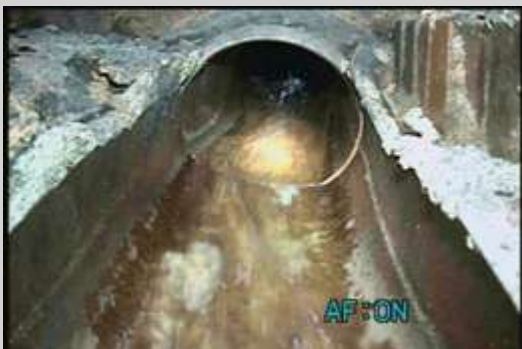
6 O'Clock Inflow

8 in. Circular Gravity Sewer
Pipe In @ 6 O'Clock

Pipe Material: **Clay** ☐ Pipe Lined

Invert Depth: **7.84** (ft.) Flow Characteristics: **Fast**

Infiltration: **None** Pipe Seal Cond: **Unknown**
